10 August 1971

ACCIDENT INVESTIGATION - PART I - CONDUCTED AUGUST 6 & 7, 1971  
AT HURRICANE MESA TEST TRACK, HURRICANE, UTAH

I. General Description of Hurricane Mesa Test Track.

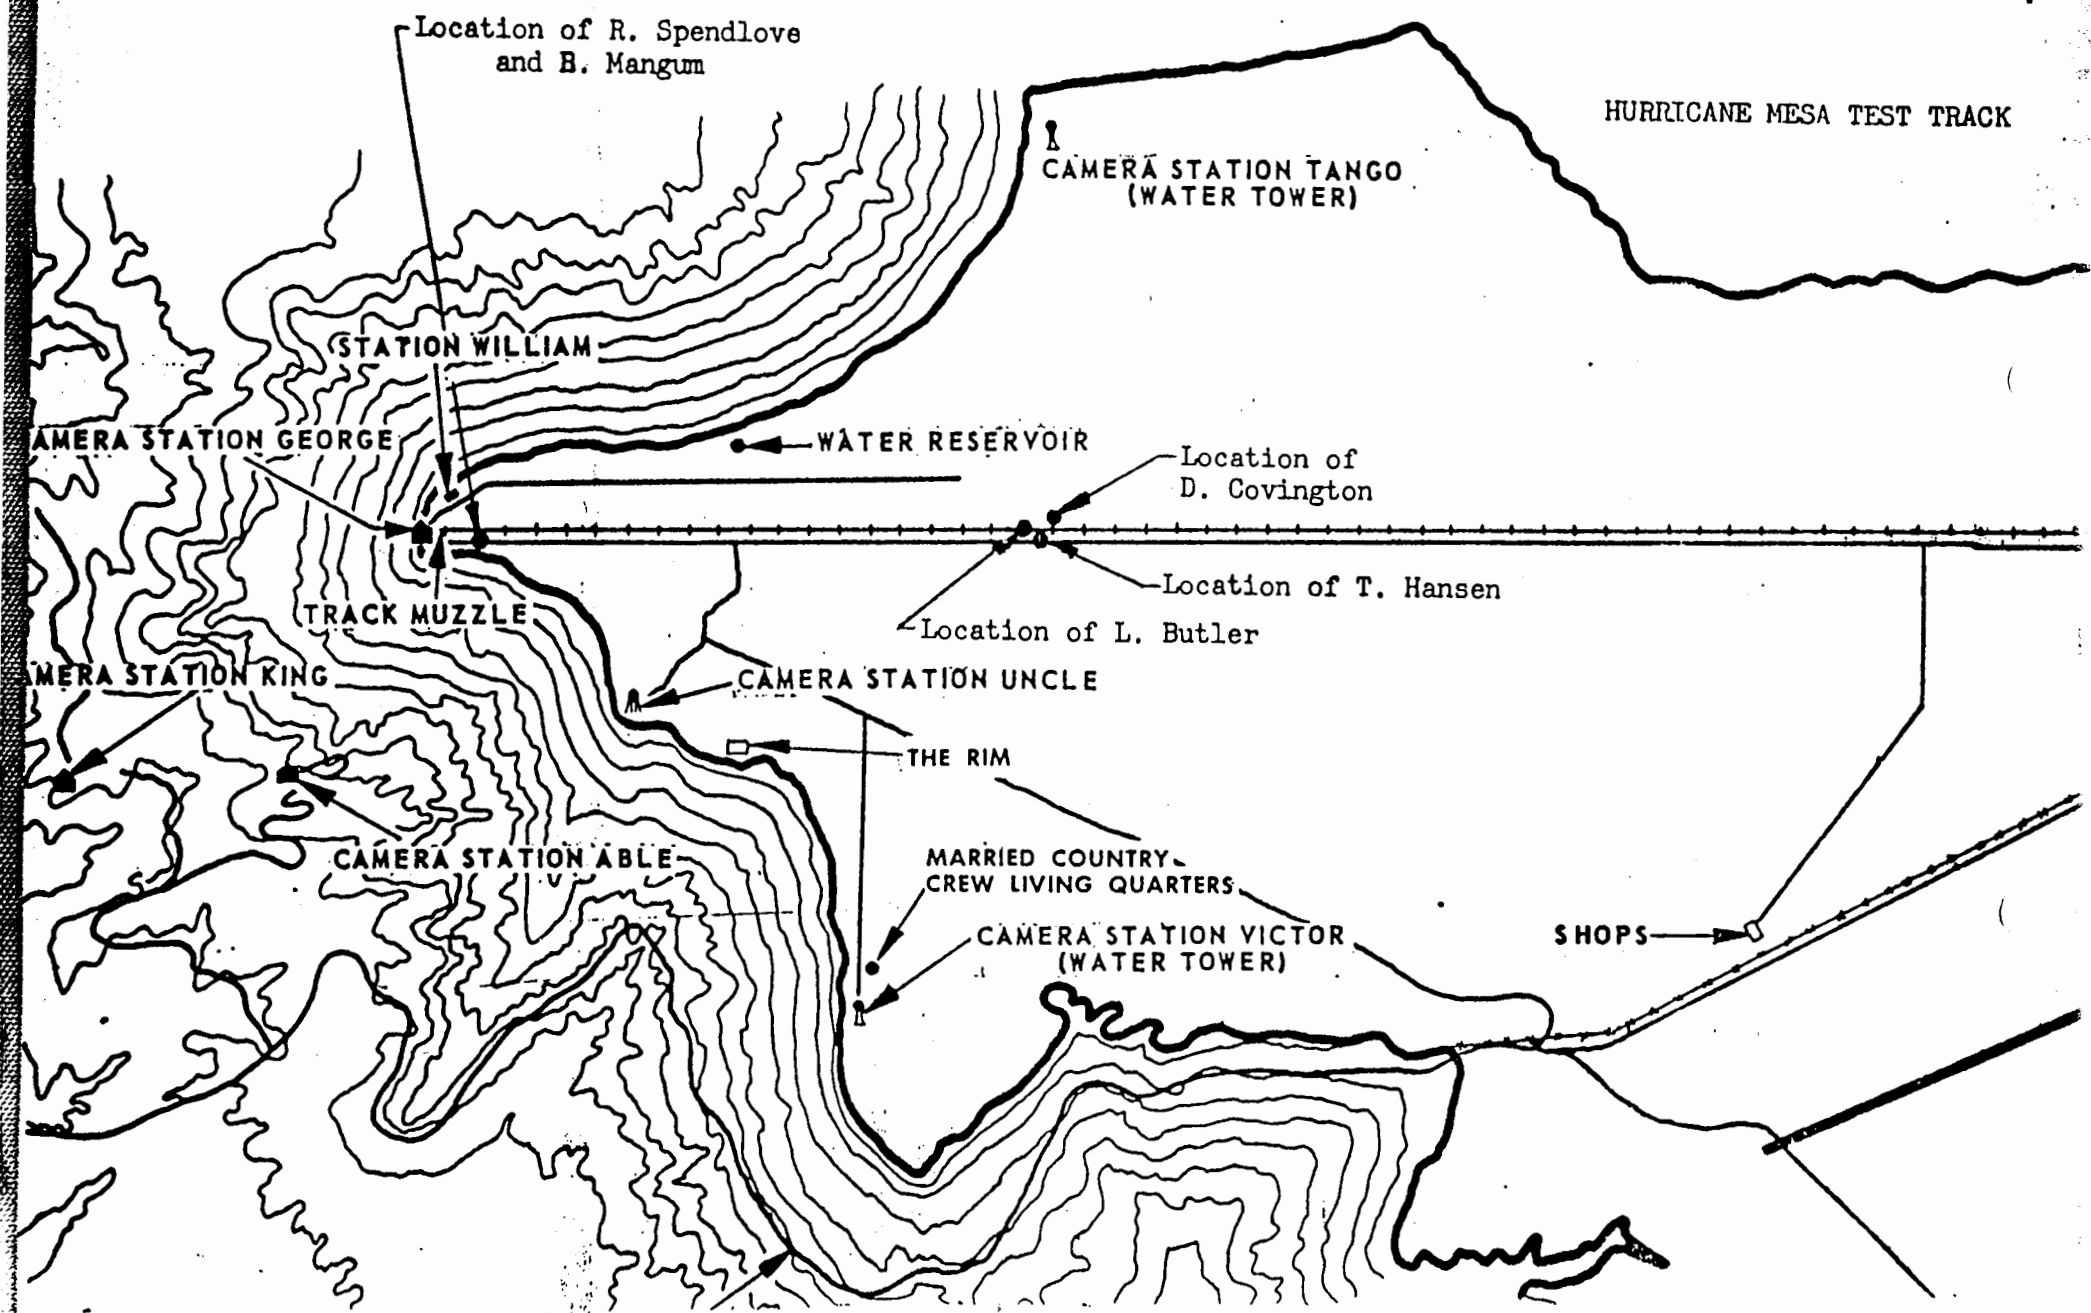
Figure 1

A high speed development sled test run was scheduled at the Hurricane Mesa Test Track on August 5, 1971, at approximately 11:00 A.M. At 8:50 A.M. that same day, during preparation for the test run, 14 HVAR rockets mounted on the Genie pusher sled ignited prematurely and two of the three sleds started down the track. There were three men working in the immediate vicinity of the sled at the time of the accident. Mr. DuRell Covington, our chief electronics expert who was reported to be just behind the Genie pusher sled, was killed. Mr. Todd Hansen who was standing alongside the track facing away from the sleds when they started moving, was burned on his hands, face, and the right side of his body near the top of his pants. He suffered further abrasions presumably from being blown down a cinder-strewn embankment as the sleds moved down the track. Mr. Larry Butler, who was sitting inside the sled astride the dummy's lap facing the dummy, grabbed onto the seat and rode the sled until it stopped. He then jumped out of the sled. His injuries consisted of bruises and abrasions.

LOCATION OF MEN AT TIME OF ACCIDENT
